Appendix J1

Geologic Assessment

**GEOLOGICAL ASSESSMENT FOR
U. S. 281 FROM LOOP 1604 TO BORGFELD ROAD,
BEXAR COUNTY, TEXAS**

6 December 2010

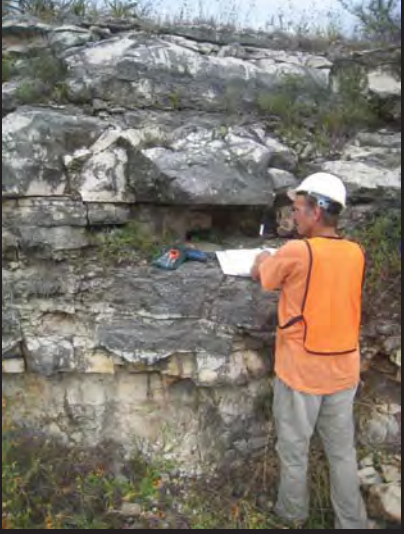
<p>281-082</p>	<p>This solution cavity is located in the west road cut of US 281. It is an enlarged bedding plane with an entrance that is 3 m (9.8 ft) wide and 0.5 m (1.6ft) high. It extends into the road cut for 1 m (3.3 ft), and has no voids extending off of it. It contains no infill material and exhibits no evidence of moisture or speleothems.</p>

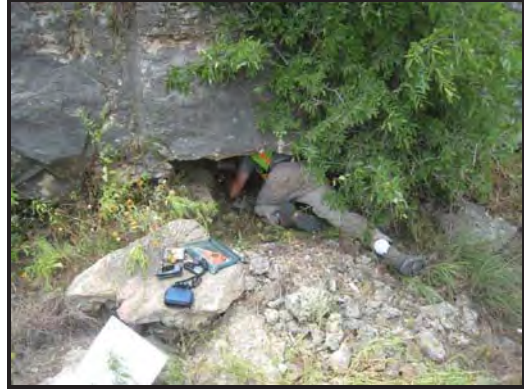
<p>281-084</p>	<p>This solution cavity is located on the west side road cut of US 281, to the south of Marshall Road. It is formed in an enlarged bedding plane. When initially assessed the entrance was 1.3 m (4.3 ft) wide and 0.35 m (1.1 ft) high, and it extended over 1.5 m (4.9 ft) into the road cut. The passage made an 80 degree turn to the right beyond which it could not be examined. It was evaluated via excavation on 18 June 2010. Using hand tools, 1.25 m³ (44 ft³) of material was removed with 9.5 person hours of effort. This enlarged the feature to 3 m (9.8 ft) in width, 1.25 m (4.1 ft) in height, and extending just over 2 m (6.6 ft) into the road cut. No continuing voids existed.</p>

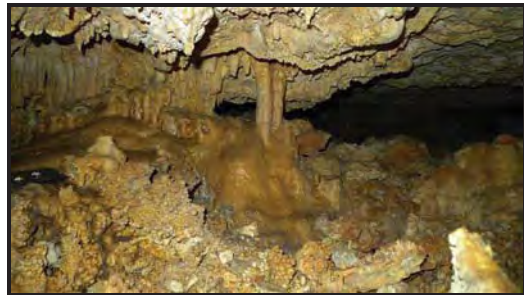
281-083

(Dripstone Cave) This cave is located in the western road cut of US 281, to the south Marshall Road. It is formed in an enlarged bedding plane. Two entrances 3 m (9.8 ft) apart join up as a wide, low bedding plane void that was likely formed under phreatic conditions. The cave is 13 m (42.7 ft) long by 5 m (16.4 ft) wide by 1 m (3.3 ft) deep. This cave is located at the very base of the road cut and receives channelized recharge from the bar ditch. The entrance had been previously excavated. The walls and ceiling of this cave are mostly covered in calcite, which gave rise to the name Dripstone Cave. The floor is covered in loose, calcite-encrusted rocks. There is little organic debris, apart from some mammal scat. Several small voids extend off of the back of the cave.

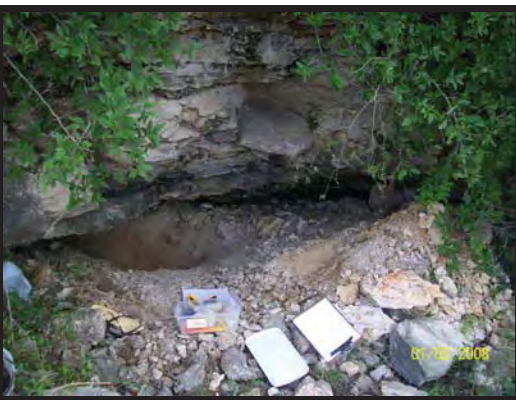
<p>281-085</p>	<p>This solution cavity is located in the western road cut of US 281, to the south Marshall Road. It is formed in an enlarged bedding plane at the base of the road cut, and it takes channelized drainage from the bar ditch. The entrance is 4 m (13.1 ft) wide and 2 m (6.6 ft) tall. When initially assessed it quickly became too low to enter, but extended at least 3 m (9.8 ft) into the road cut and was considered to be potentially humanly-enterable. Evaluation via excavation was conducted on 18 June 2010 for 6 person hours, removing 0.75 m³ (26.5 ft³) of material from the feature. The floor was lowered, enabling the back of the feature to be examined. Post-excavation dimensions of the feature were 4 m (13.1 ft) in width and 2.5 m (8.2 ft) in height and extended 3 m (9.8 ft) into the road cut. No voids continued on.</p>

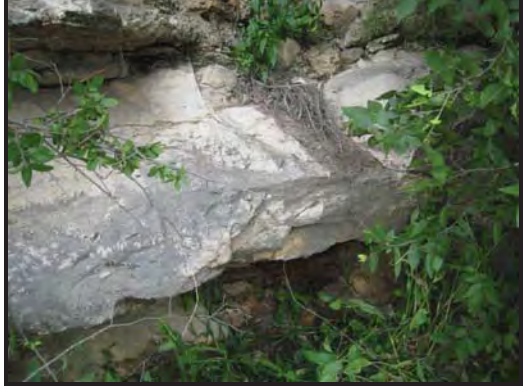
281-086	<p>This solution cavity is located in the western road cut of US 281, to the south Marshall Road. It is formed in an enlarged bedding plane. The entrance is 2 m (6.6 ft) wide and 0.45 m (1.5 ft) high. It extends 1 m (3.3 ft) into the road cut, at which point a small void that is not humanly-enterable continues for an unknown distance. It is formed at the base of the road cut, taking channelized drainage from the bar ditch. Previous excavation has occurred here, as evidenced by a tailings pile just outside of the entrance.</p>

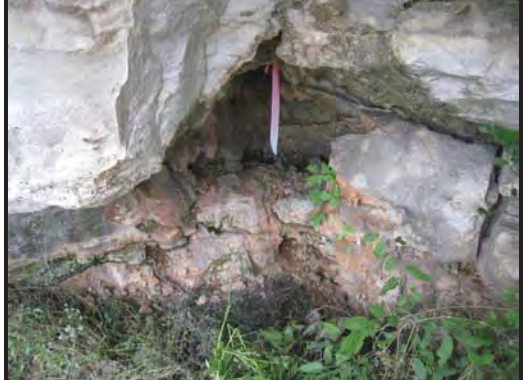
281-087	<p>This solution cavity is located in the western side road cut of US 281, to the south Marshall Road. It is formed in an enlarged bedding plane. The entrance is 3 m (9.8 ft) wide and 1.5 m (4.9 ft) high. It extends 1.5 m (4.9 ft) into the road cut. Some of the surfaces are covered in calcite. There are no mesocavernous voids extending from the feature.</p>

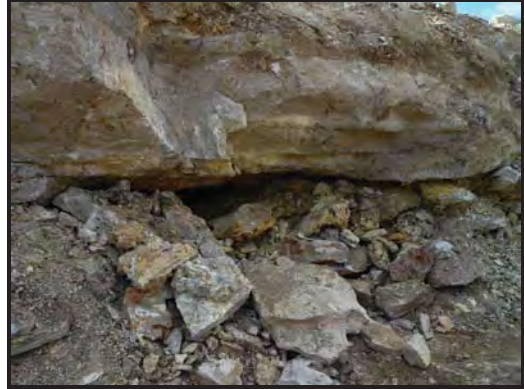
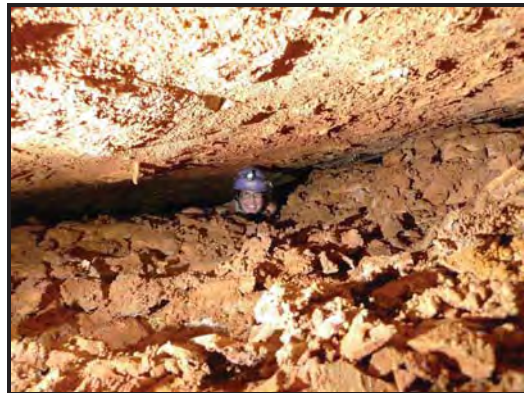
281-089	<p>(Zombie Cave) This karst feature is located in the road cut just south of Zombie Cave, and upon excavation and investigation was found to connect to it. See the description of 281-088 for more information.</p>

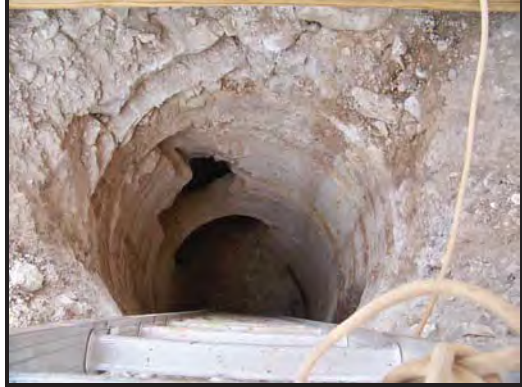
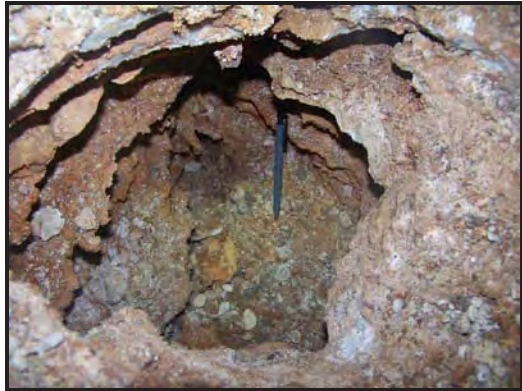
<p>281-091</p>	<p>(Zombie Cave) This is another feature located in the road cut south of Zombie Cave. This feature was exposed during road widening activities in August 2010. Excavation conducted at that time determined its connection to Zombie Cave. See the description of 281-088 for more information.</p>

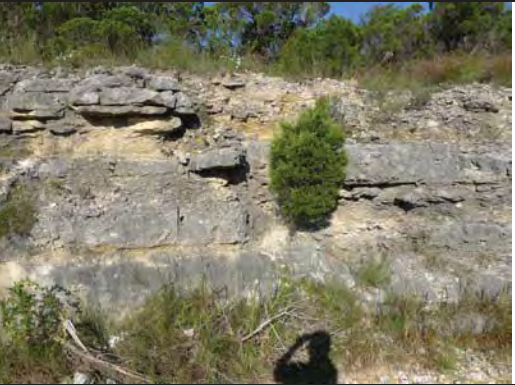
<p>See map at 281-088.</p>
<p>281-092</p>	<p>This feature is a fault exposed in the road cut on the west side of US 281. It has a strike of 53° and a dip of 50° with 1 m (3 ft) of displacement.</p>

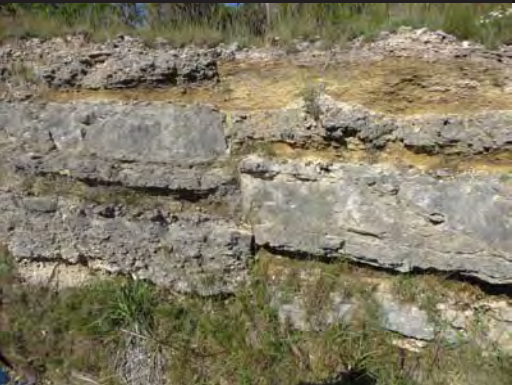
<p>281-093</p>	<p>This feature is a fault exposed in the road cut on the west side of US 281. It has a strike of 55° and a dip of 83° NW.</p>

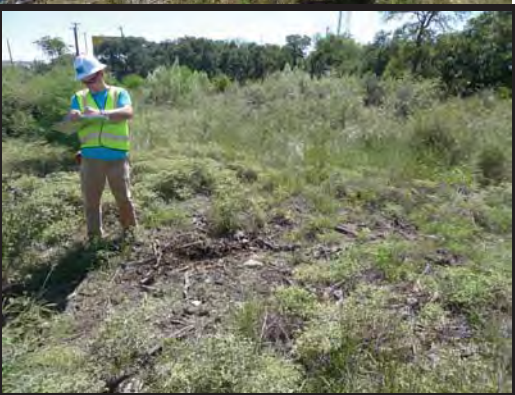
<p>281-095</p>	<p>This solution cavity is located in the eastern road cut of US 281. When initially assessed, it was 1 m (3.3 ft) wide, 1.3 m (4.3 ft) tall, and it extended into the road cut for 0.5 m (1.6 ft). It contained some gravel infill that may be associated with construction excavation activities. The walls were partially covered with calcite. It is developed along a fracture with a trend of approximately 133 degrees. It was excavated on 1 October 2010. This effort removed 1 m³ (35 ft³) of material utilizing 6 person hours of labor. The feature was enlarged along the fracture to yield post-excavation dimensions of 1 m (3.3 ft) wide by 2 m (6.6 ft) tall, and it extended 1 m (3.3 ft) into the road cut. The fracture narrowed nearly to closure, with no airflow.</p>

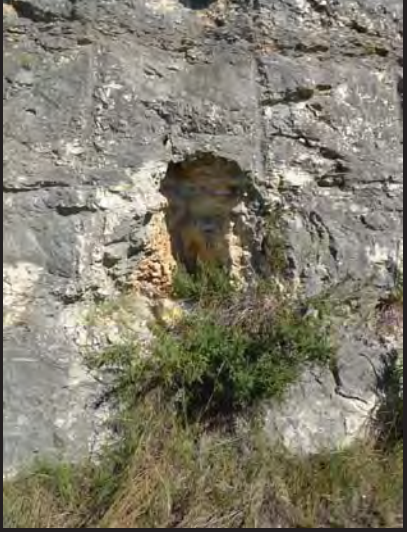
<p>281-096</p>	<p>This enlarged fracture is situated in the eastern road cut of US 281. It is 1 m (3.3 ft) wide, 1.2 m (3.9 ft) tall, and extends into the road cut for 1.5 m (4.9 ft). It contains some gravel infill that may be associated with construction excavation activities.</p>

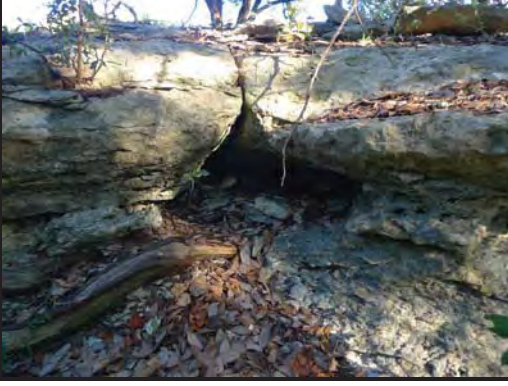
<p>281-098</p>	<p>This solution cavity is an enlarged bedding plane on a creek bank. The entrance is 0.75 m (2.5 ft) wide, 0.3 m (1 ft) tall, and it extends into the creek bank for 1.6 m (5.2 ft). A fracture is present in the feature that has a trend of approximately 150 degrees. It has a coarse-grained infill of rocks. The roof of the feature is only about 0.5 m (4.9 ft) thick, and is in the process of being eroded away due to proximity to the creek. This feature is a result of that process.</p>

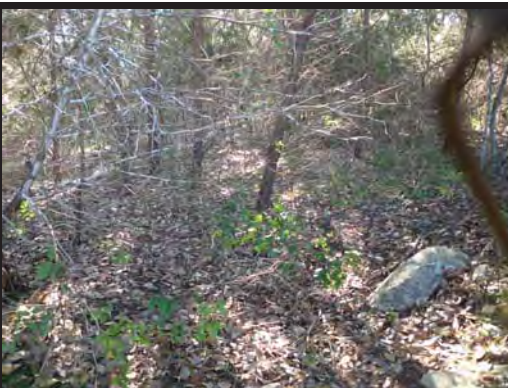
<p>281-099</p>	<p>This closed depression is probably not karstic and was viewed from the ROW through a fence, but access was denied to the private property where it is located, barring further evaluation. It is 1 m (3.3 ft) long, 0.8 m (2.6 ft) wide, and 0.2 m (0.7 ft) deep. It appeared to have infill of leaf litter and organic sediment. It may be surface disturbance associated with fence building.</p>

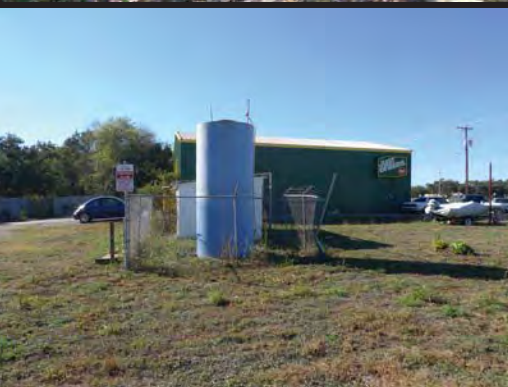
<p>281-100</p>	<p>This feature is a water well near some businesses. The well could not be fully assessed because it is contained in a shed to which access was not obtained.</p>

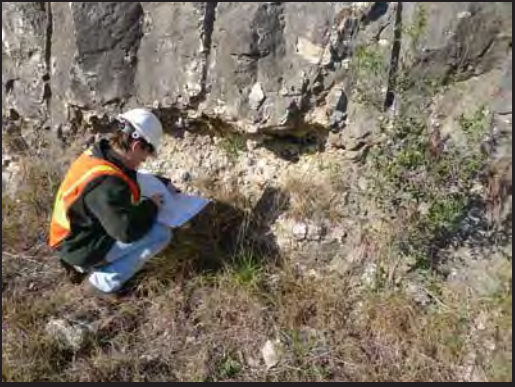
281-103	<p>This solution cavity is located on private property on the west side of US 281. The entrance is 0.25 m (0.8 ft) wide, 0.2 m (0.7 ft) long, and when initially assessed it dropped 0.4 m (1.3 ft) to a floor composed of organic debris and soil that was loose to a depth of loose. Preliminary excavation lowered the floor 0.1 m (0.15 ft), but more excavation would have required removal of some of the bedrock walls. This was recommended to assess karst invertebrate habitat, but right of entry for that purpose was denied.</p>

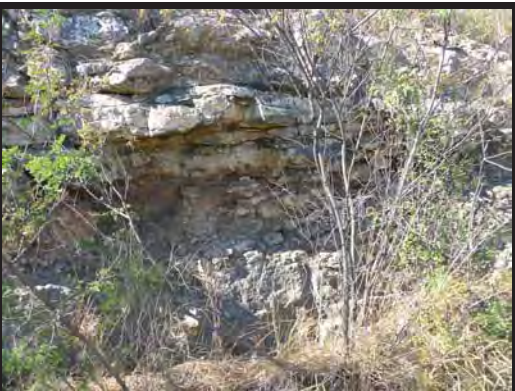
281-106	This is a zone of solutionally enlarged fractures in the streambed of West Elm Creek with a bearing of 106°.

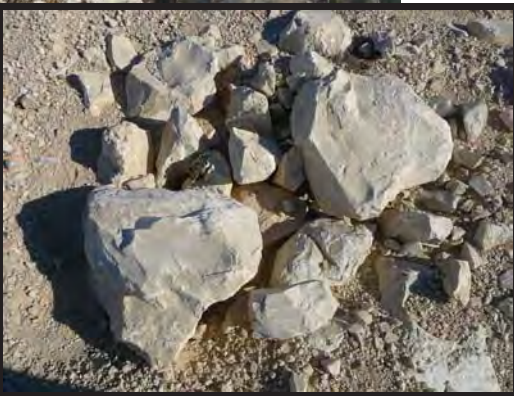
281-107	This appears to be a solution cavity encountered during down-cutting of bedrock grade in a private property construction area. It is 1.5 m (4.9 ft) long, 1.3 m (4.3 ft) wide, and is 0.25 m (0.8 ft) deep. It has an infill of rocks and fine white silt (powdered bedrock) that appears to be the result of construction activities. It was recommended for excavation to make a full evaluation, but right of entry for excavation purposes was not obtained.

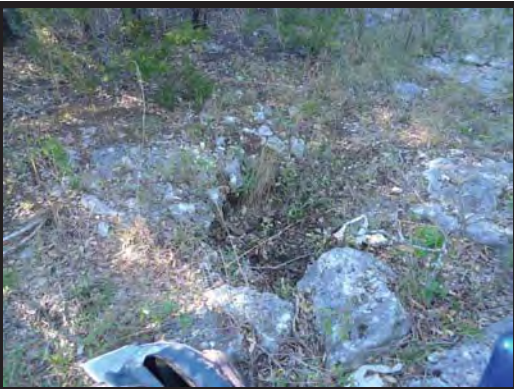
281-108	This non-karst closed depression is located on the east US 281 ROW in an area that was partially cleared of trees in the past. It is 0.8 m (2.6 ft) long, 0.6 m (2 ft) wide, and is 0.3 m (1 ft) deep. When initially assessed, it had an infill of fine-grained organic sediment. It was excavated on 16 November 2010, which resulted in the removal of 5 cm (0.2 ft) of soil to reveal a bedrock floor. This feature is probably a result of tree removal.

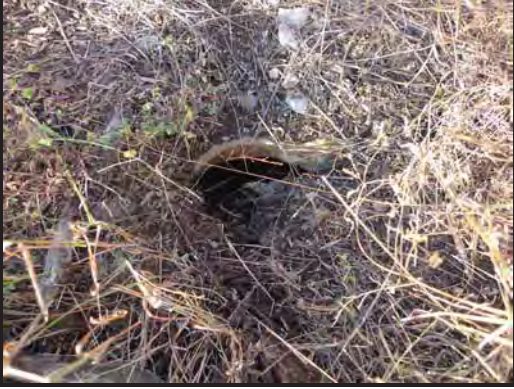
281-109	<p>This possible solution cavity is located on private property on the west side of US 281. It consists of two 10 by 20 cm (0.3 by 0.6 ft) holes that are 1 m (3.3 ft) apart, one of them open and one plugged. The eastern hole drops for 0.2 m (0.7 ft) to dirt fill. This feature was recommended for excavation. No determination could be made about this feature due to lack of ROE for excavation purposes. This may be an animal burrow under a slab of rock that has been mostly filled with soil by site grading.</p>

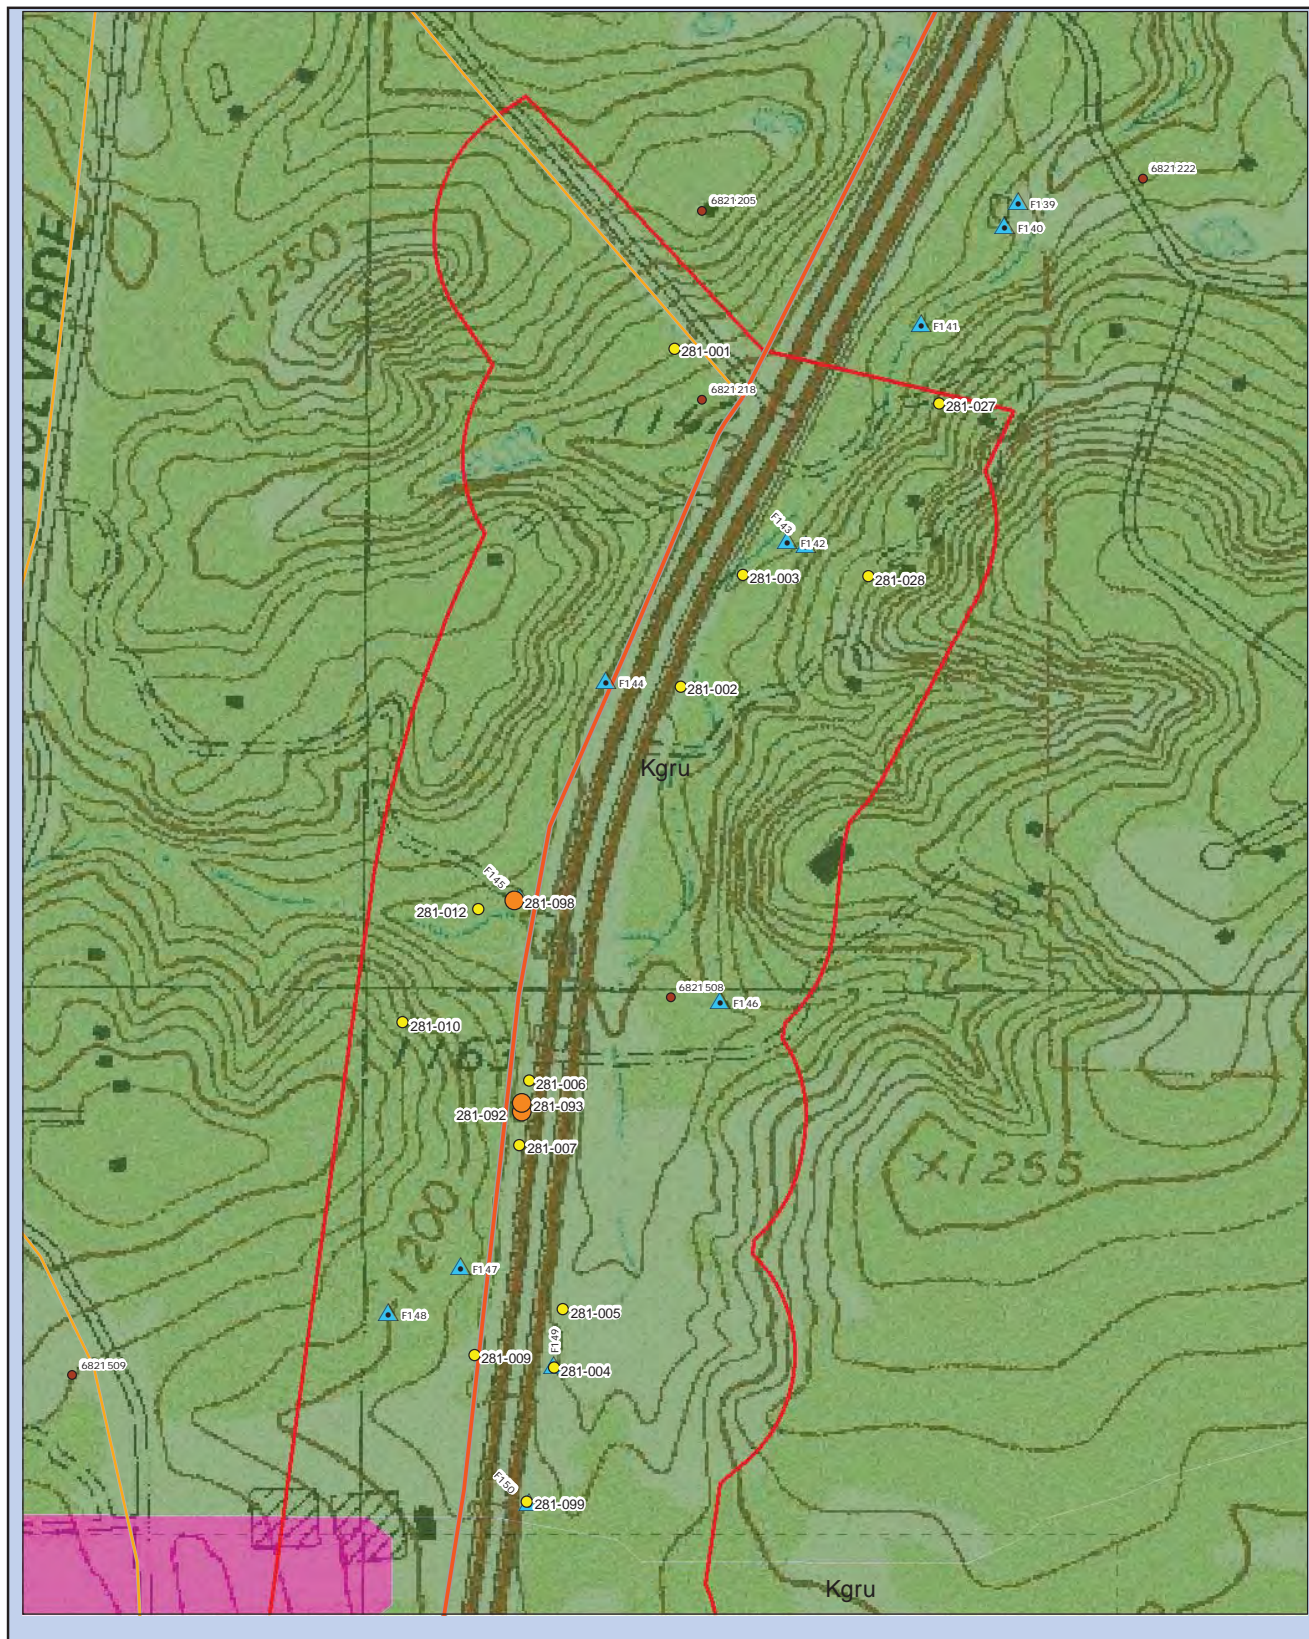
Plate D-8 Geology Map

Geology data sources: USGS SIM 2873, 2005
TNRIS, Geologic Atlas of Texas, 2010
